# The City of Tumwater’s Annex to the Natural Hazards Mitigation Plan for the Thurston Region

**A RESOLUTION** of the City Council of the City of Tumwater, Washington adopting the 2009 update to the Natural Hazards Mitigation Plan for the Thurston Region.

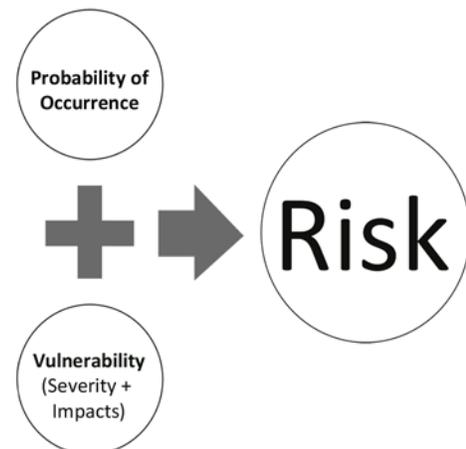
Figure 1: Risk is a subjective estimate of the combination of a hazard's probability of occurrence and a community's vulnerability.

An adjective description (High, Moderate, or Low) of the overall threat posed by a hazard is assessed for the next 25 years. Risk is the subjective estimate of the combination of any given hazard's probability of occurrence and vulnerability.

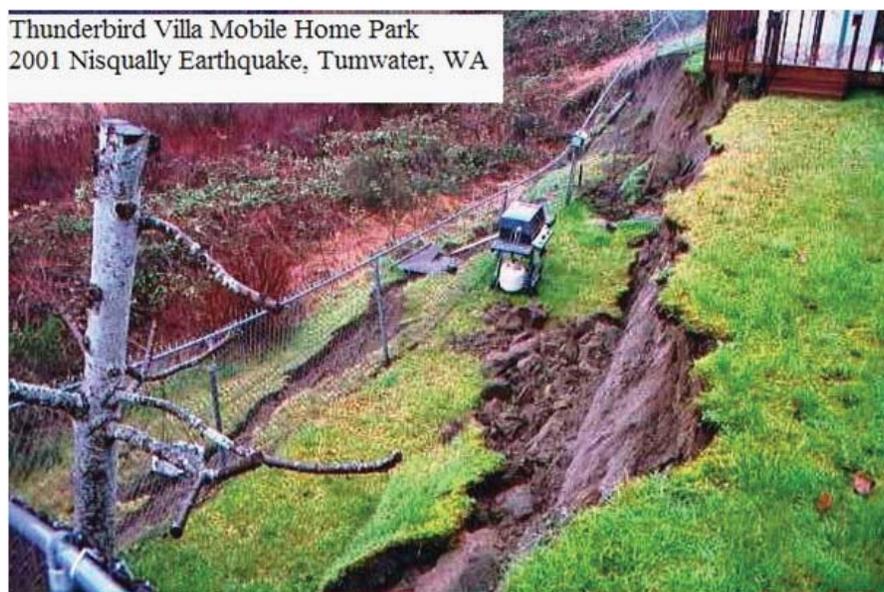
The Western Plaza mobile home park experienced some settling due to liquefaction, although it was to a lesser degree than that seen at Tumwater Mobile Estates.<sup>2</sup> Thunderbird Villa on Dennis Street had damage as well. The Tumwater Fire Department observed at least one home in Thunderbird Villa that had the backyard settle several feet abruptly off the back of the home.<sup>2,5</sup>

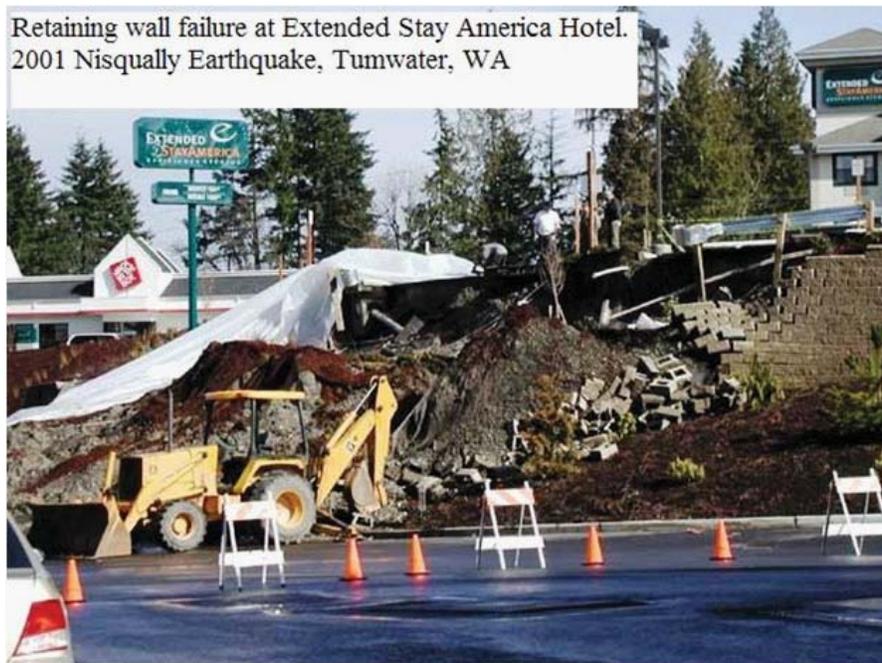
Most City buildings had at least some minor damage. Both the main fire station and station #2 on Linwood Avenue, Tumwater City Hall, the Tumwater Timberland Library, Old Town Center, the historic Crosby house, the Henderson House Museum, and portions of the Tumwater Valley Municipal golf course all were damaged in the earthquake.<sup>2,6,7</sup> There were approximately 173 reports of damage to private property in Tumwater.<sup>8</sup> The Best Western hotel located on the bluff above the Palermo wellfield had a portion of the rear parking lot settle and start to slide down the hill.<sup>2</sup> The Extended Stay America facility near the Highway 101/Crosby Boulevard interchange had a large retaining wall give way which broke a water line.<sup>2,9</sup>

<sup>9</sup>Picture of retaining wall failure at Extended Stay America hotel at Crosby Boulevard/US 101 interchange.

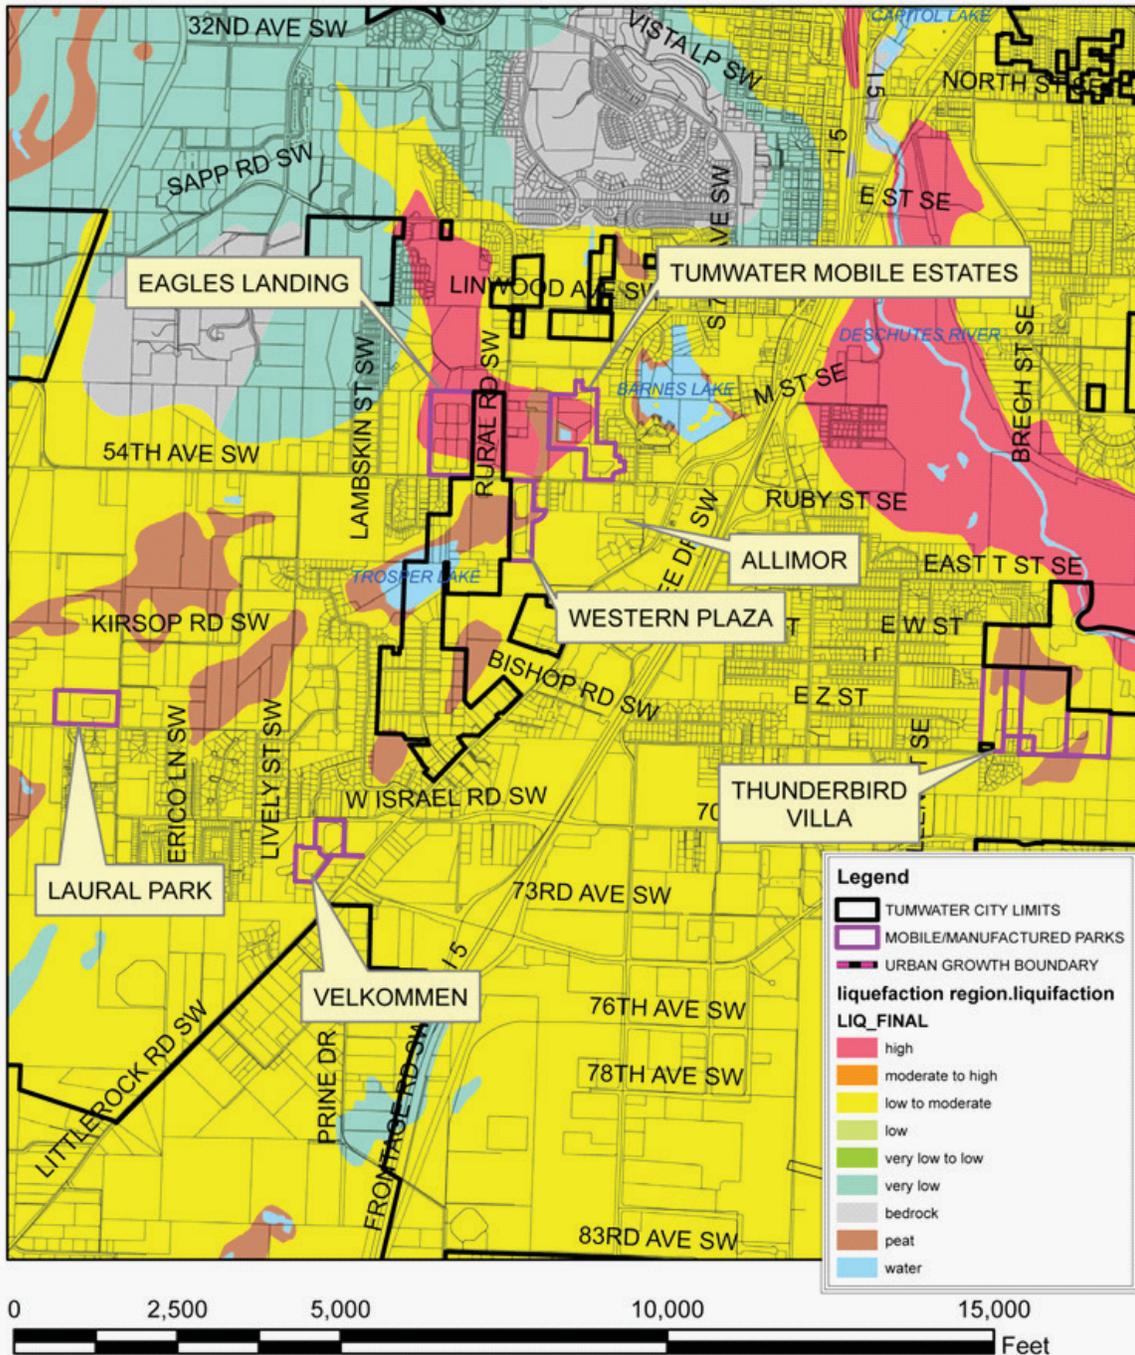
## TUMWATER MOBILE&MANUFACTURED HOME PARKS LIQUEFACTION SOIL HAZARDS

Four of the seven large manufactured/mobile home parks within Tumwater are located in areas of high liquefaction hazards and/or on peat.<sup>1</sup> These include Eagles Landing, Tumwater Mobile Estates, Western Plaza (all located on Trospen Road), and Thunderbird Villa on Dennis Street. The latter three sustained damage during the 2001 Nisqually earthquake.<sup>2</sup>

<sup>1</sup>Map-Tumwater Mobile&Manufactured Home Parks Liquefaction Soil Hazards

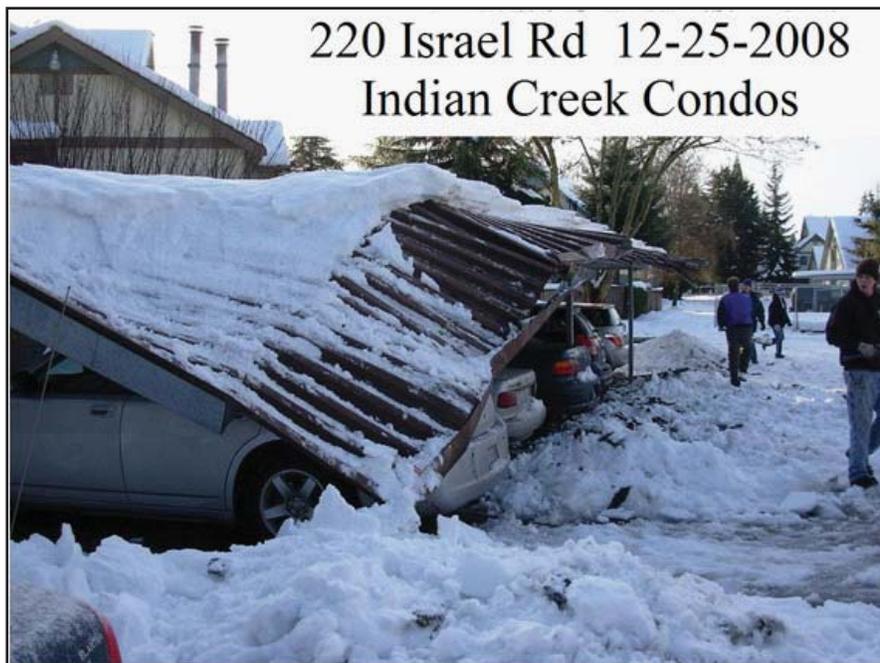
During the December 2008 snow storm carports at several apartment buildings in Tumwater collapsed including the Breckonridge Heights apartments, Indian Creek condos (pictured below), and Capitol Heights apartments.<sup>2</sup> The Olympics West Retirement facility on Trospen Road was evacuated due to the threat of roof collapse from heavy snow.<sup>3</sup> Other relatively minor damage occurred to the main Tumwater Fire Station when the weight of the snow tore the gutters off of the building. No injuries were reported due to the collapses.

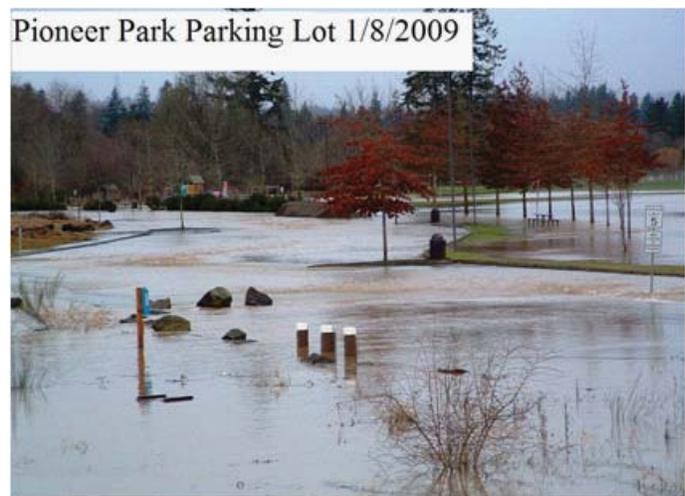
Pioneer Park located on Henderson Boulevard is inundated almost yearly. A visible current of water typically flows through the entire parking lot area.<sup>1</sup> Fortunately, the building which houses the restrooms has yet to be flooded.<sup>2</sup> The building is also used as a storage shed for mowers, tractors, and other equipment used for park maintenance.<sup>3</sup> In addition, a sewer lift station is also at the same location.<sup>4</sup> Access to the building and the sewer lift station has not been possible during floods due to the floodwaters surrounding the site and flowing over the access road.<sup>4</sup>

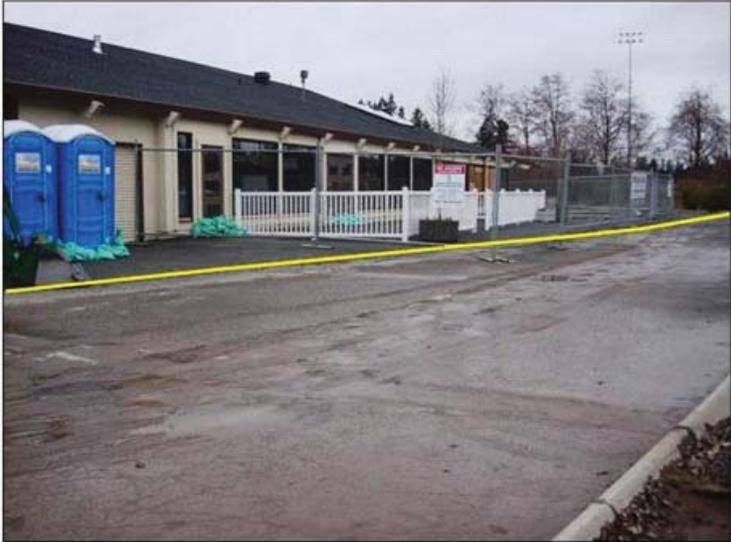
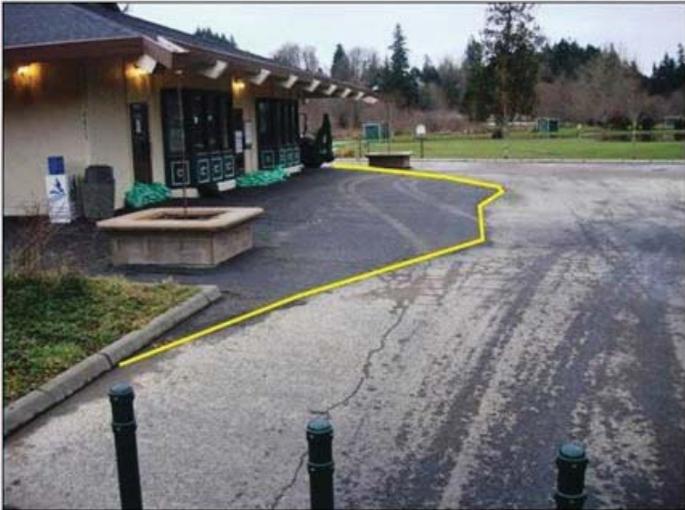
# 1/09 FLOOD

## 14.5 FOOT WATERLINE

14.5 foot waterline data from Rainier gauge on Deschutes river.  
Produced by Tumwater Parks and Recreation Dept. (Chuck Denney).

The Tumwater Valley golf course is within the 100-year floodplain and is also flooded almost yearly. Floodwaters routinely cover the golf course and get to within a couple of feet of the door of the clubhouse/restaurant (only inches below the level needed to flood the interior). Chuck Denney (Tumwater Parks and Recreation Director) produced of a one page demonstration of the water level at the Tumwater golf course clubhouse in the January 2009 flood. Two photos with yellow lines drawn on them indicate the extent of the water levels near the clubhouse and a citation of the water level at the floodgauge at Rainier on the Deschutes River (14.5’).

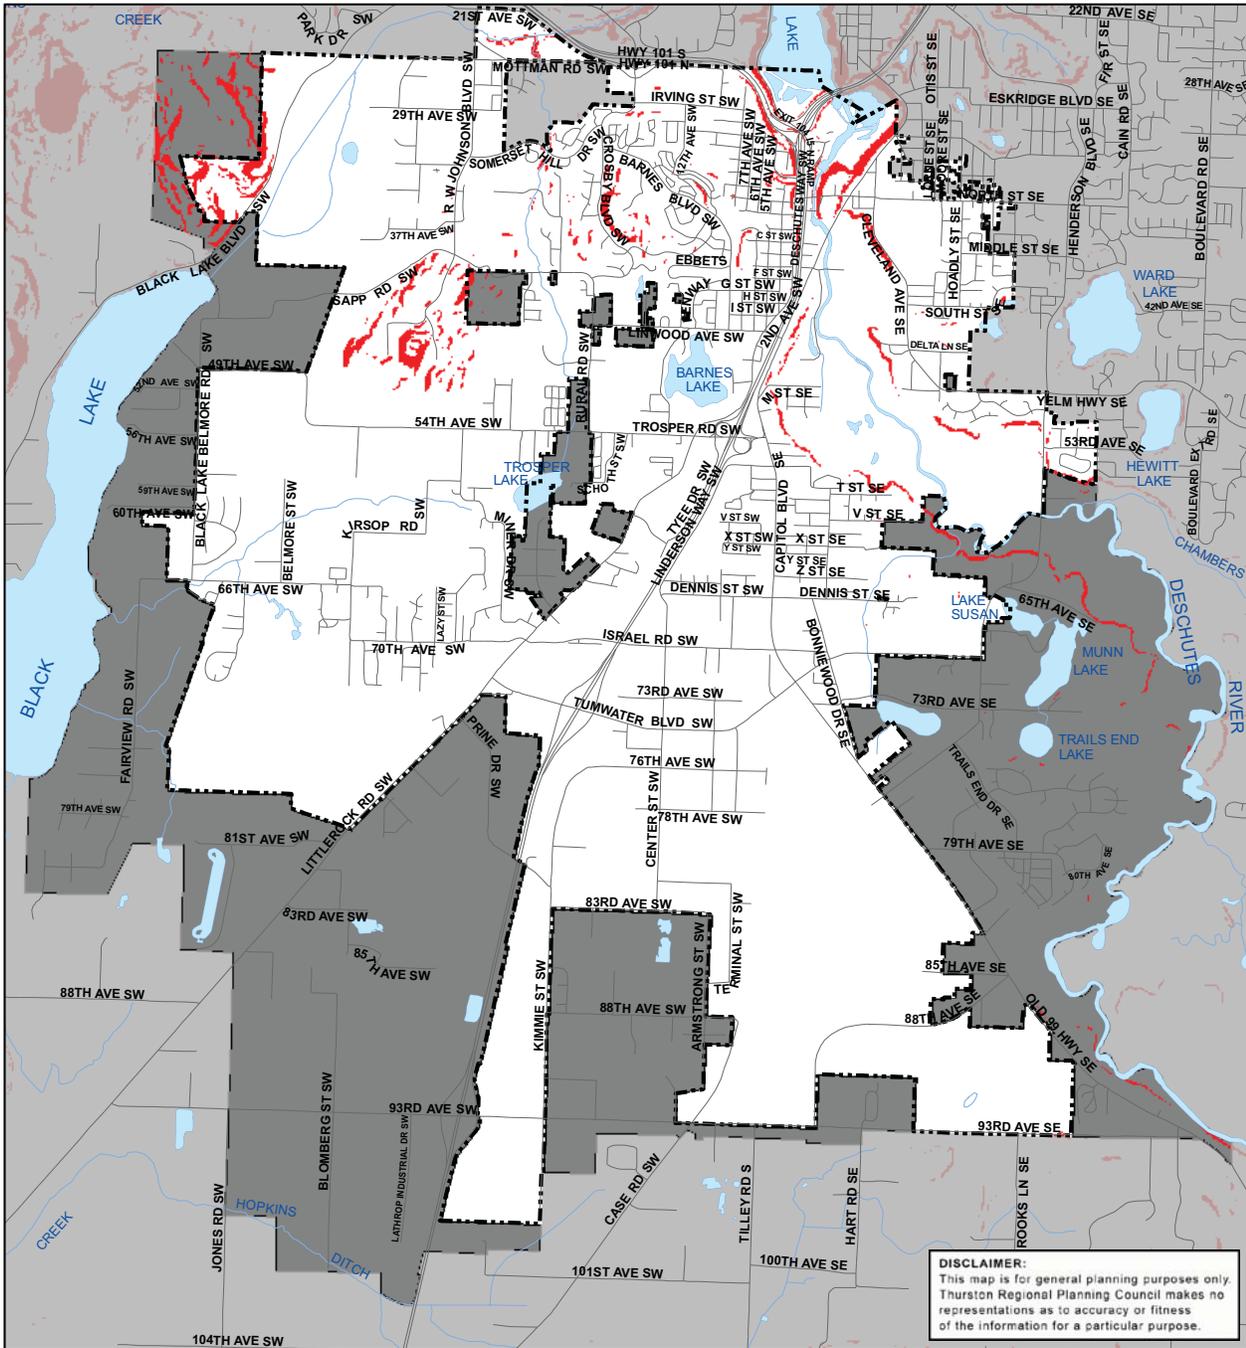
### City of Tumwater Steep Slopes

- Slopes Over 40%
- City Limits
- Urban Growth Boundary

Although Tumwater has several areas of steep slopes, most of the landslides have been concentrated in one area across the Deschutes River from Historical Park. The vulnerability level is low (as compared to moderate for the region) due to the fact that the main critical infrastructure (sewer mains) that were damaged by the landslides in 1965 and 1996 have been moved to Deschutes Parkway and stabilized to withstand future earthquakes. The railroad remains in the same location as the previous landslides but is not a significant transportation connection for Tumwater.

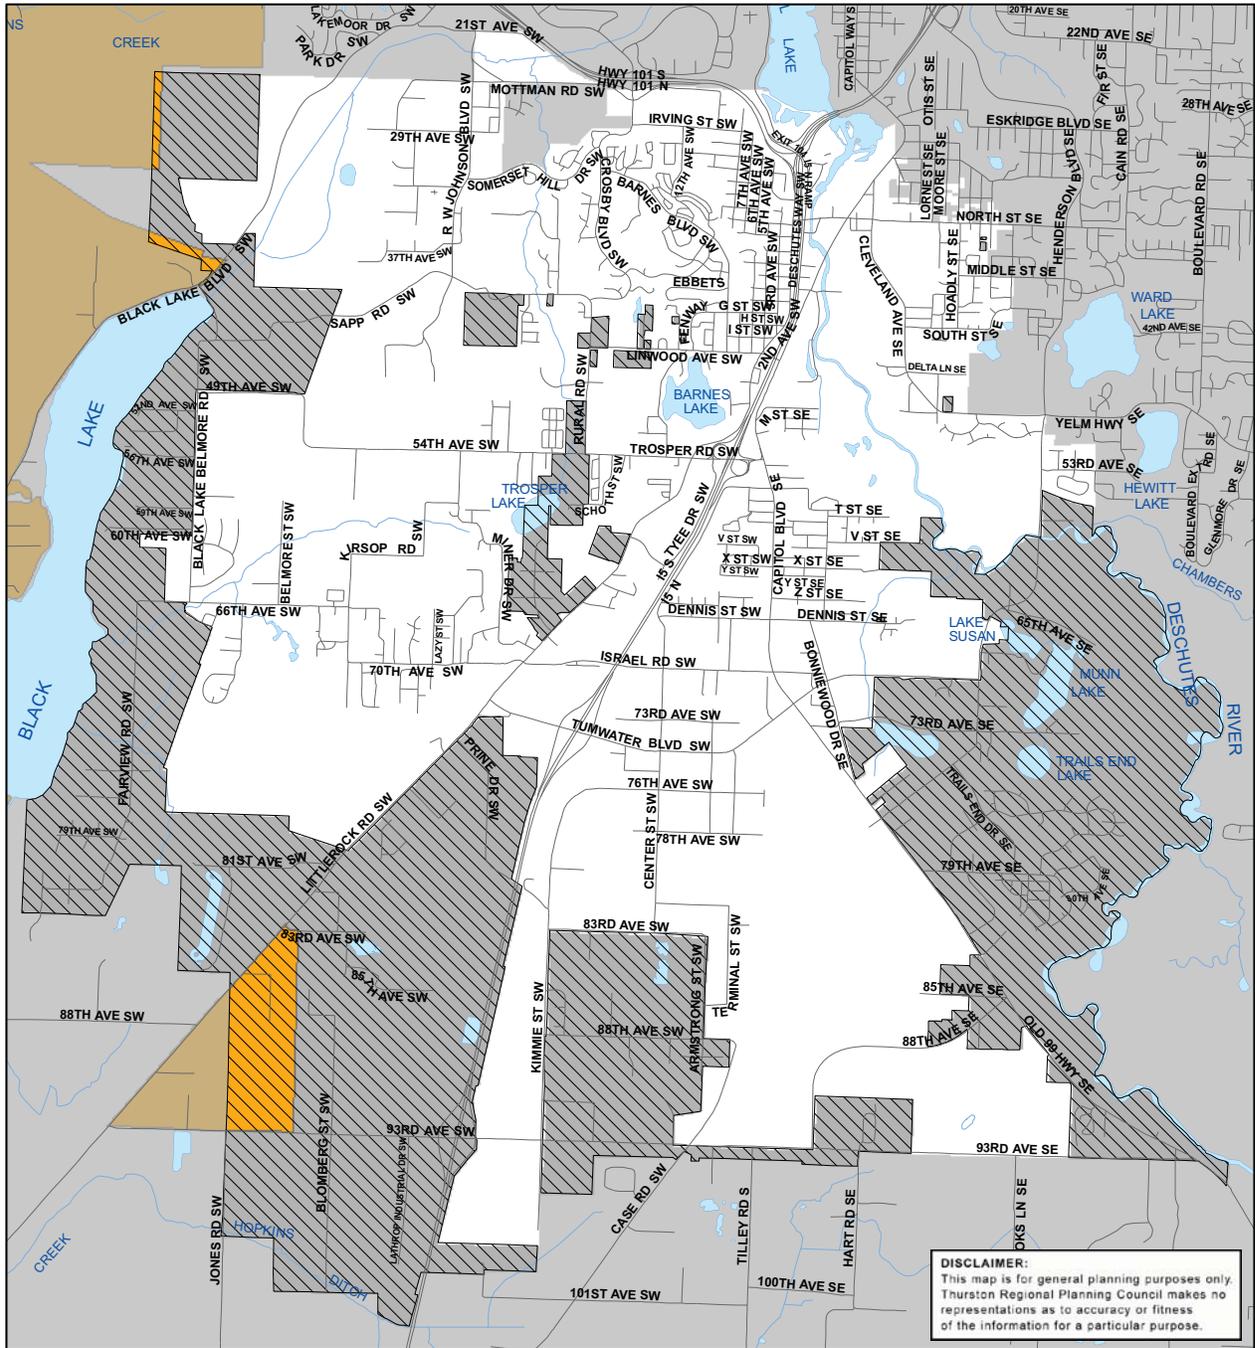
**City of Tumwater  
Wildfire Hazard Areas**

- Wildfire Hazard Areas
- City Limits
- Urban Growth Boundary

As shown on the City of Tumwater Wildfire Hazard Areas map there are no wildfire hazard areas within the City limits of Tumwater. There are a couple of relatively small wildfire hazard areas on the fringes of the Tumwater Urban Growth Area (UGA). One area is near the intersection of Littlerock Road and 93rd Avenue. The other small area is in the northwest corner of the UGA in the vicinity of the Jones Quarry.
