Chapter 4.4

Landslide Hazard Risk Assessment

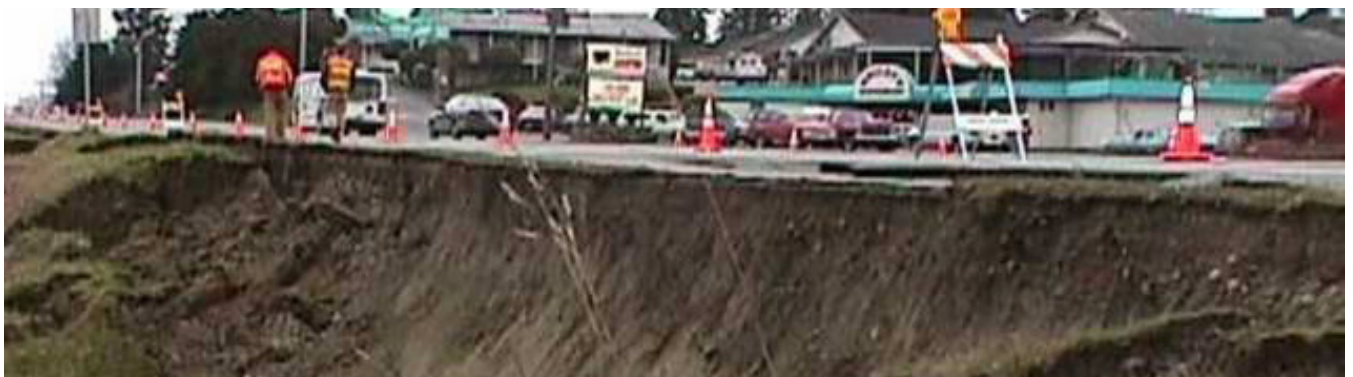
Geologists determined that the landslide – likely caused by heavy winter rains – was a reactivation of an ancient slide. The 66-acre slide caused substantial damage to the private community which maintains its own streets and water treatment system.⁶

The landslide hazard persists for the Carlyon Beach/Hunter Point area although movement has ceased. Thurston County has subsequently identified 54 parcels in this area as a designated landslide hazard area. The County's Critical Areas Ordinance prohibits substantial improvements to these properties.
